TRANSFUND NEW ZEALAND

1998 Pilot Safety Audit of Traffic Control at Road Work Sites: Summary Report

Review and Audit Division
Report No. RA98/699S

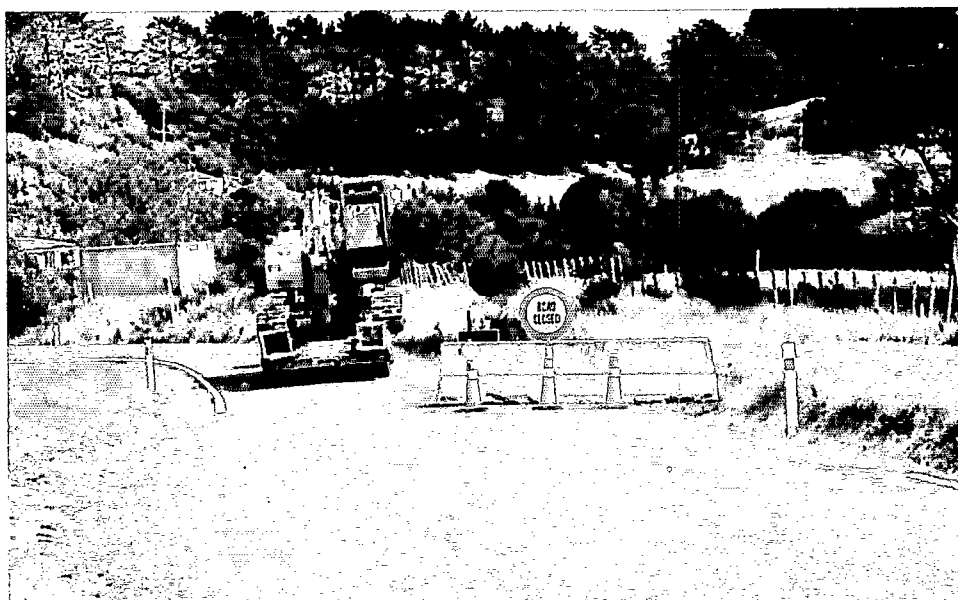
Road closed with a concrete barrier placed at 90 degrees to road.
